Lead Paint Survey

Crystal Pool

Victoria, BC

NWEG Project: 12711

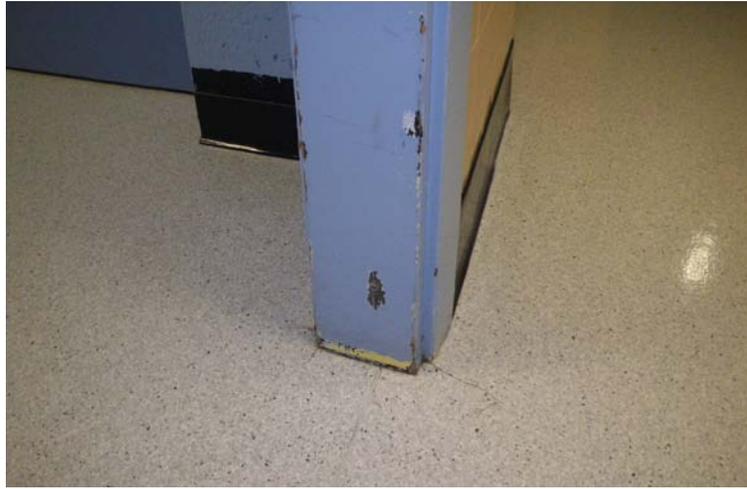
Photo 1:

Sample Number: 12711-02
Location: Entrance to Men's
Change Room
Material: Paint Chips
L.C.: <0.10 % wt

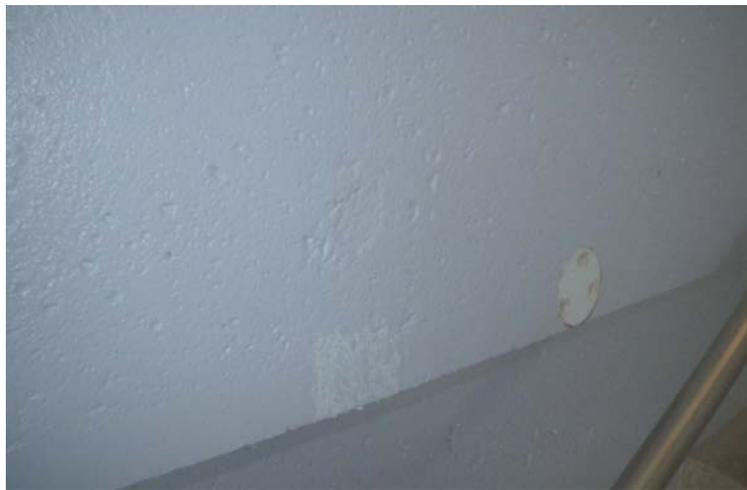
Photo 2:

Sample Number: 12711-03
Location: Bleachers
Material: Concrete Paint Chips
L.C.: 0.11 % wt

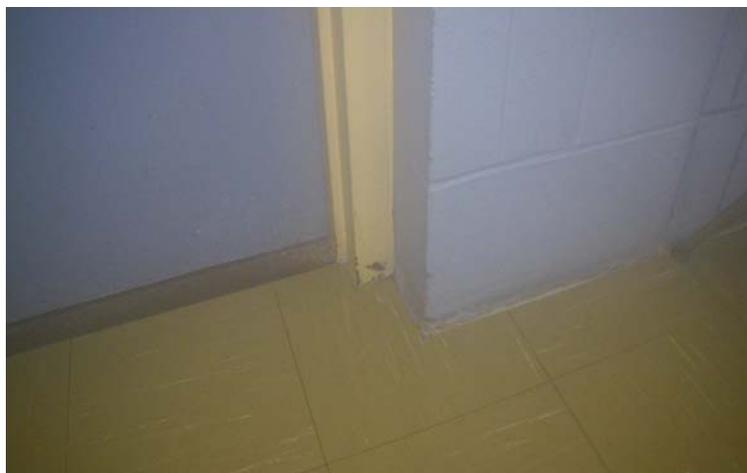
Photo 3:

Sample Number: 12711-04
Location: Upper level-Door
Frame
Material: Paint Chips
L.C.: <0.010 % wt

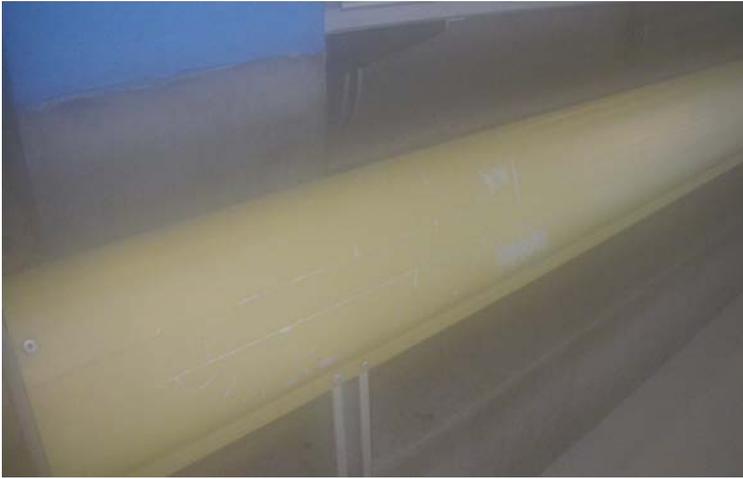
Photo 4:

Sample Number: 12711-05

Location: Bleacher Backs

Material: Paint Chips

L.C.: 1.1 % wt

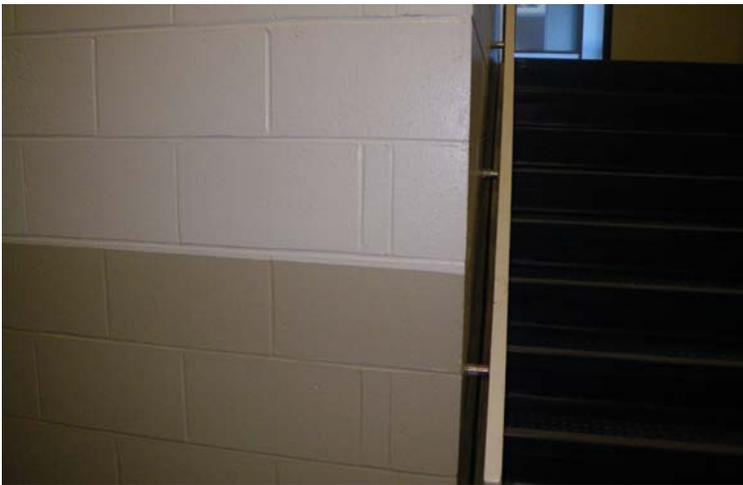
Photo 5:

Sample Number: 12711-06

Location: Lower Level Stairs

Material: Light Brown Paint
Chips

L.C.: 0.012 % wt

Sample Number: 12711-07

Material: Brown Paint Chips

L.C.: <0.033 % wt

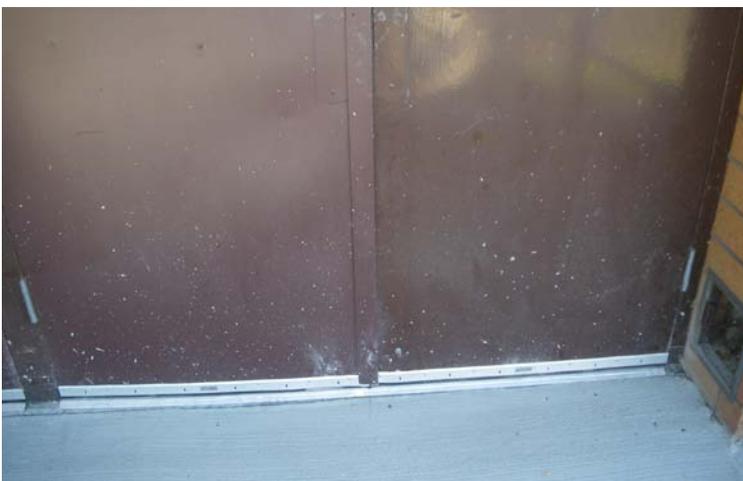
Photo 6:

Sample Number: 12711-08

Location: Exterior Door

Material: Paint Chips

L.C.: 0.39 % wt
