Evaluation Report

Crystal Pool & Fitness Centre

FINAL REPORT JULY 14, 2011

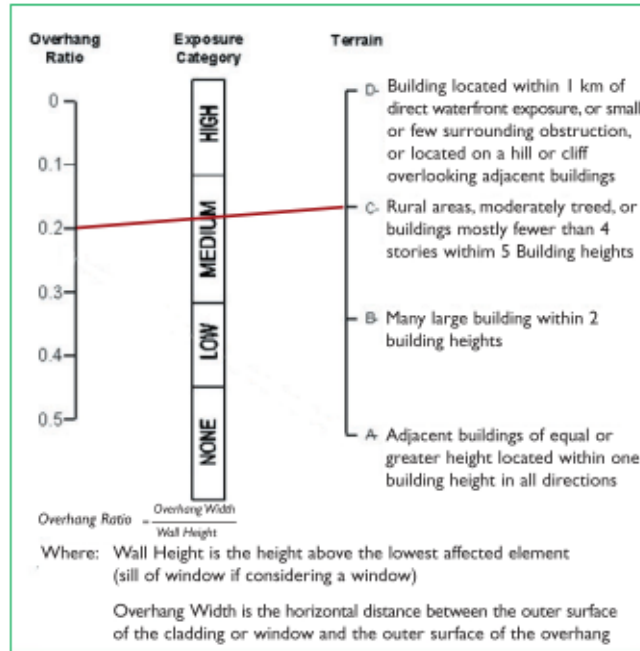
The Crystal Pool and Fitness Centre was designed by John Di Castri in 1969/70 and was constructed in 1971. The facility is set in an urban location more than 1km distance from direct waterfront exposure. This places it on the mid point of “medium” in the exposure category shown on the following Nomograph Chart. The facility has several overhang widths, with the typical overhang ratio being 0.2 with a class “C” terrain. This particular “nomograph” has been developed for the severe climate of British Columbia.
